# SOSnake PVC Double-Coated Hose

**SOSnake PVC Double-Coated Hose is a durable firefighting and industrial hose designed for demanding operating environments. The hose features a fully double-coated construction with both inner lining and outer jacket made from PVC, providing excellent resistance to abrasion, chemicals, UV radiation and sea water.**

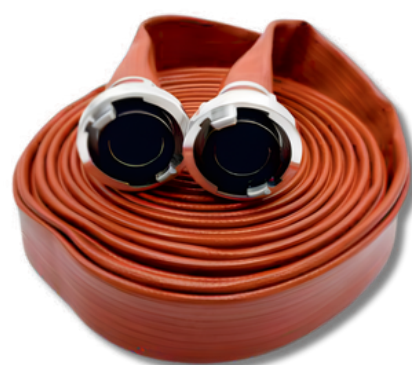
- Double-coated **PVC lining and outer jacket** construction
- High resistance to **chemicals, sea water, UV and ozone**
- Excellent **abrasion and mechanical damage resistance**
- Smooth inner surface for efficient water flow
- Durable structure designed for demanding environments
- Available with multiple coupling systems

| Specification | Value |
|---|---|
| Hose Construction | PVC lining and PVC outer jacket |
